Hope UMC Bell Tower

Bell Tower Alteration Phase One Design Presentation

January 15, 2025

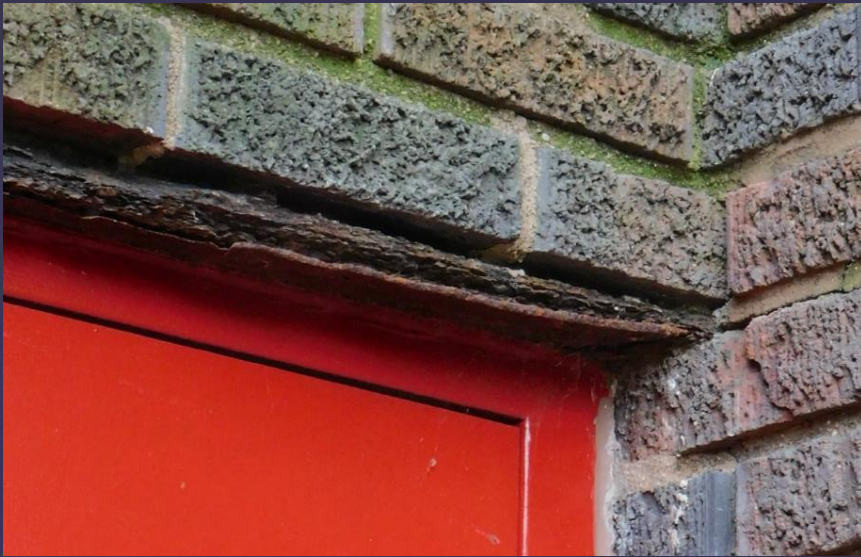
The original steel used to build the church is rusting and the rust scale is building up and causing damage to the adjacent masonry. In the above photo, the steel lintel located over an exterior door on the tower is severely rusted and bending the steel out of shape. In the photo to the right, steel embedded inside of the tower belfry has rusted and the rust scale has actually fractured the red clay tile block used to build the inner tower walls.

Option A – Remove top of tower – approx.  
\$315,000-\$350,000

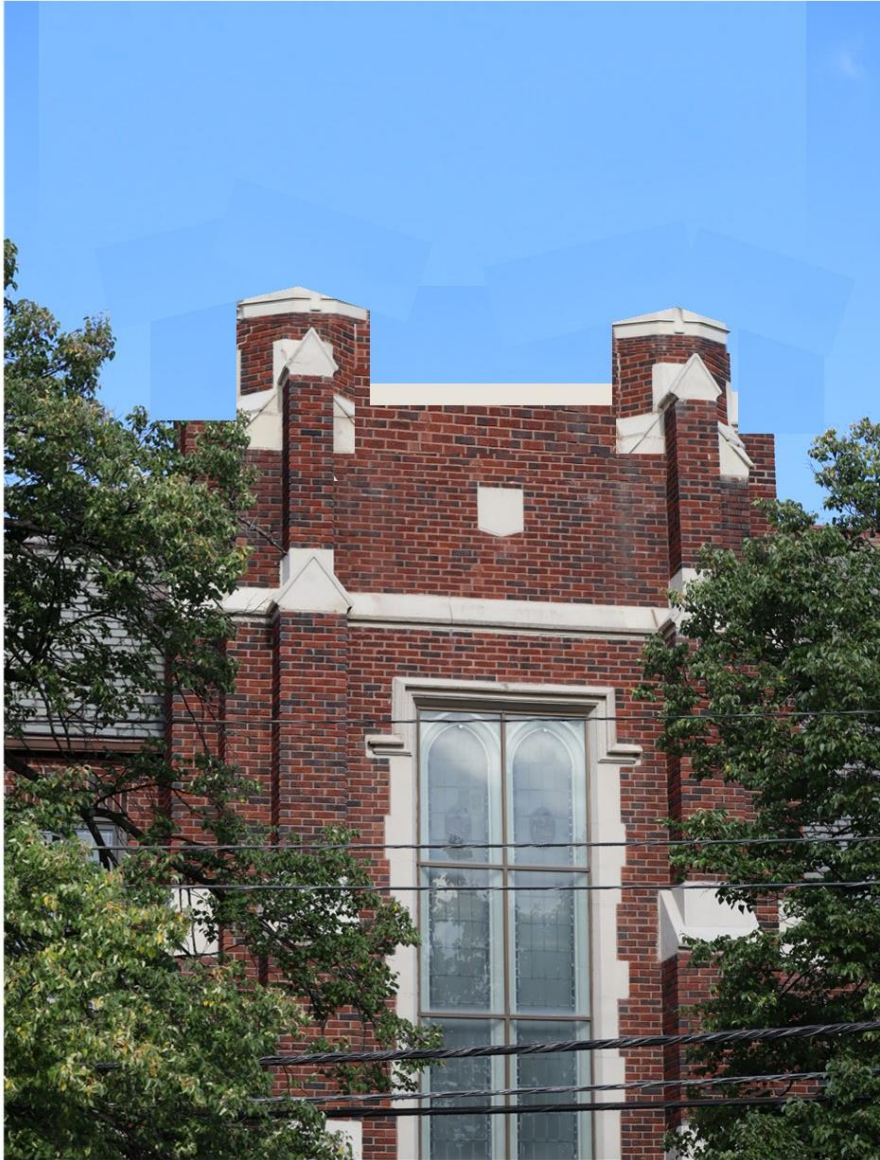
DRAWING NUMBER  
**A-1a**  
© 2024 HD, DFRANCESCO and Sibbold, Inc.

After discussions with the church representatives, Frost drafted this crude visual to describe to an architect the intent to remove part of the tower while maintaining the architectural style.

The original tower had a flat cap across the top but removing the tower height created a more squat tower. By incorporating a crenelated effect, the top of the tower will feel lighter and have a decorative appearance.

**EAST ELEVATION CURRENT**  
1/8" = 1'-0"

**EAST ELEVATION NEW**  
1/8" = 1'-0"
